Maritime Administration's Safety Corner

Fall 2024
Volume 9 Issue 4

Preventing GPS Signal Interference

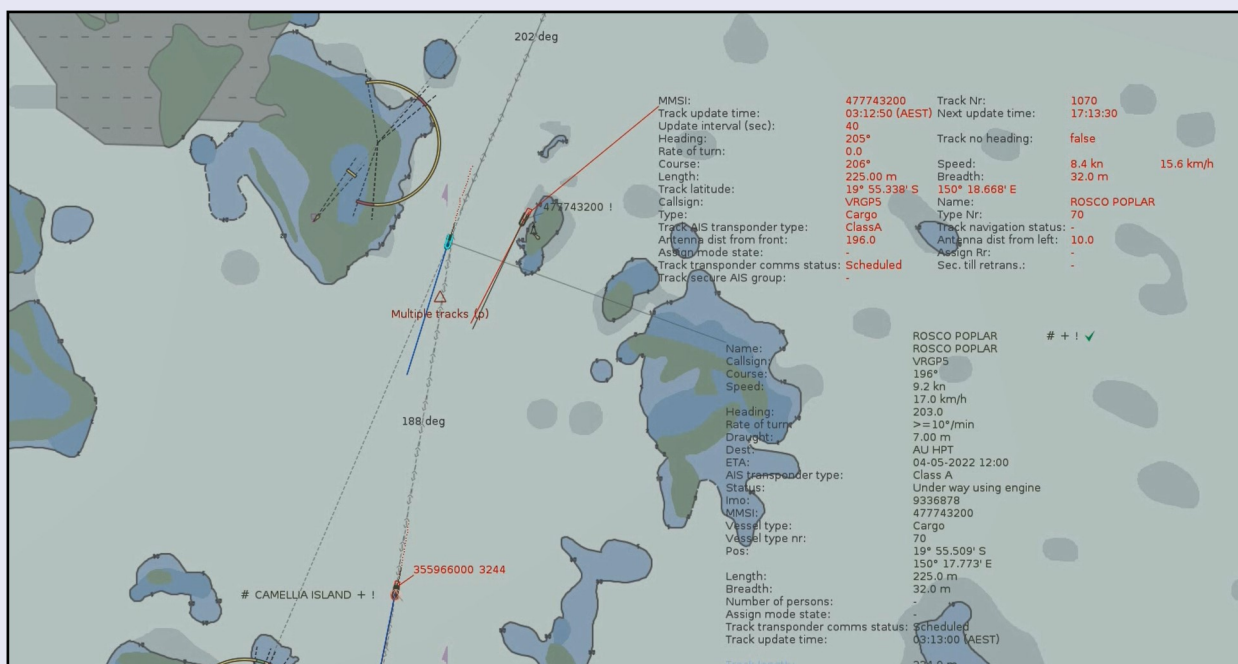
The ATSB found that during the early stages of the pilotage, one of the ship's three GPS units began outputting incorrect positional data, likely due to an antenna malfunction. Because the bridge navigational equipment, including the electronic chart display and information system (ECDIS) and automatic identification system (AIS), was receiving a single position input from the same GPS unit, the ship's position was incorrectly displayed on all these systems. However, no alarms were triggered from the failure, as the GPS unit incorrectly indicated that position accuracy was within acceptable limits.

The investigation found that the pilot and bridge team solely relied on GPS positioning to monitor the ship's progress and did not maintain a proper lookout through use of radar and visual observations. As a result, they failed to identify that the position reported on the ECDIS units was incorrect and that the ship had deviated significantly from the planned track.

It was also identified that the pilot had not correctly configured their portable pilot unit (PPU) to be independent of the ship's position sensors. This resulted in the PPU displaying the same incorrect position as the ship's ECDIS units.

The picture above from the Australian Maritime Safety Authority shows the difference between the actual position of the vessel (in red) and where the pilot and crew thought they were (in blue).
